WEST GOSHEN SEWER AUTHORITY

2017 ANNUAL CONSULTING ENGINEER'S REPORT WASTEWATER SYSTEM

March 2018

**2017 ANNUAL CONSULTING ENGINEER'S REPORT
WEST GOSHEN SEWER AUTHORITY
CHESTER COUNTY, PENNSYLVANIA**

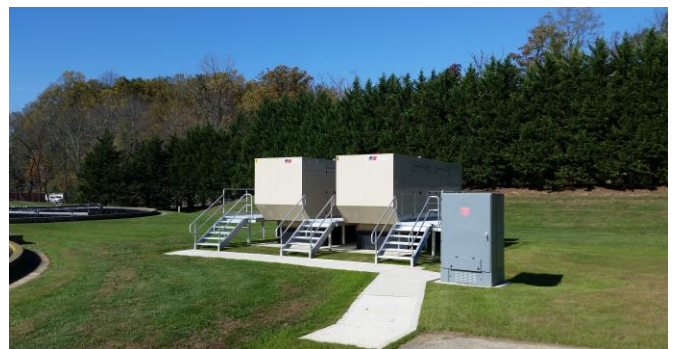
Two (2) 500kw Emergency Diesel Generators and Trvstar Permanent Docking Station at WWTP

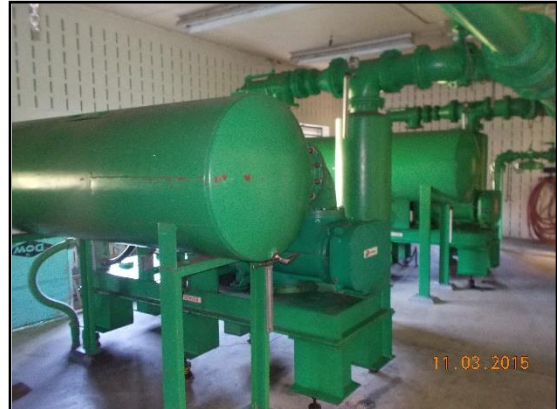
Blowers
125 HP 18 psig PD Blower 3,340 scfm

Overall, the blowers appear to be in good working condition. One (1) blower provides enough air for treatment and mixing of the existing aeration tanks with the second blower providing a swing-stand-by for redundancy, and the third able to provide more than enough air for the aerobic digester that was removed in 2017.

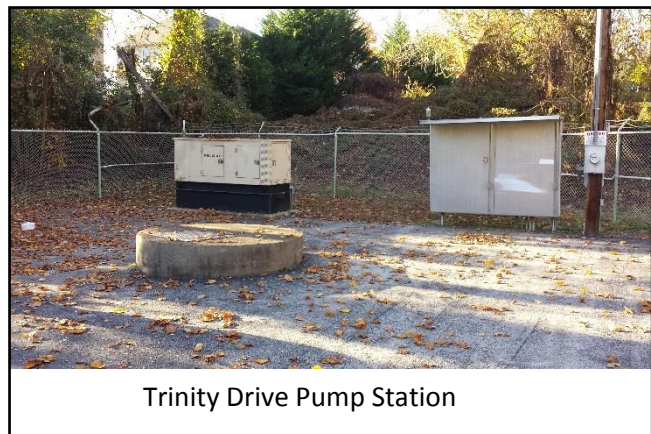
Trinity Drive Pump Station

- Operations staff reports that the water service to the pump station site no longer functions.
 - Proposed improvement – Install new water service to the pump station site.
- Concrete and ferrous metal deterioration from exposure to hydrogen sulfide gas was observed in the wet well. Concrete deterioration has led to exposed rebar in the concrete.

- Proposed improvement – Complete investigation to determine full extent of concrete and ferrous metal deterioration. Repair deteriorated concrete and possibly add liner to prevent future deterioration. Repair and replace ferrous metal as necessary and coat/paint to prevent future deterioration.

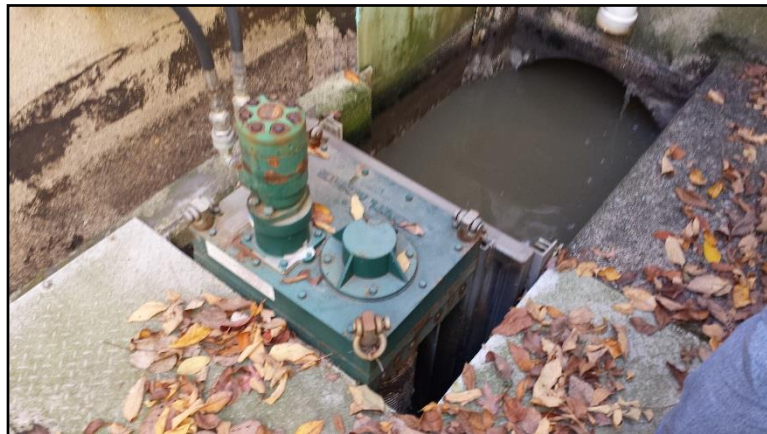
Washington Street Equipment

- The wet well contains raw waste which results in a NEC Class I Div. I hazardous area electrical classification. The electrical lighting in the wet well is not rated for use in hazardous areas. In addition, significant corrosion of the electrical components in the wet well was observed.

- Concrete and ferrous metal deterioration from exposure to hydrogen sulfide gas was observed in the wet well. Further investigation is needed to determine the extent of the concrete deterioration throughout the wet well.

- Proposed improvement – Upgrade electrical equipment in the wet well to meet hazardous area requirements.

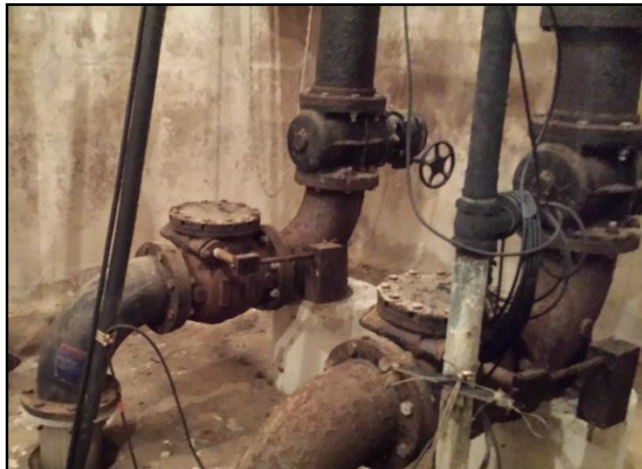
Fern Hill Equipment

- The wet well contains raw waste which results in a NEC Class I Div. I hazardous area electrical classification. The electrical lighting in the wet well is not rated for use in hazardous areas. In addition, significant corrosion of the electrical components in the wet well was observed.
 - Proposed improvement – Upgrade electrical equipment in the wet well to meet hazardous area requirements.
- The wet well is not physically separated from the electrical room. Additional work should be done to physically separate the electrical gear and provide a safe environment. For example the wire rope hoist is not explosion proof.

- Concrete and ferrous metal deterioration from exposure to hydrogen sulfide gas was observed in the wet well. HRG observed and Township Staff reported that the header piping and valves in the wet well are experiencing severe corrosion. Township staff noted that they have epoxy painted this pipe and valves the past, but the painting has not held up. Further investigation is needed to determine the extent of the concrete and pipe deterioration throughout the wet well.

- Proposed improvement – Complete investigation to determine full extent of concrete and ferrous metal deterioration. Repair deteriorated concrete and possibly add liner to prevent future deterioration. Repair and replace ferrous metal as necessary and coat/paint to prevent future deterioration.

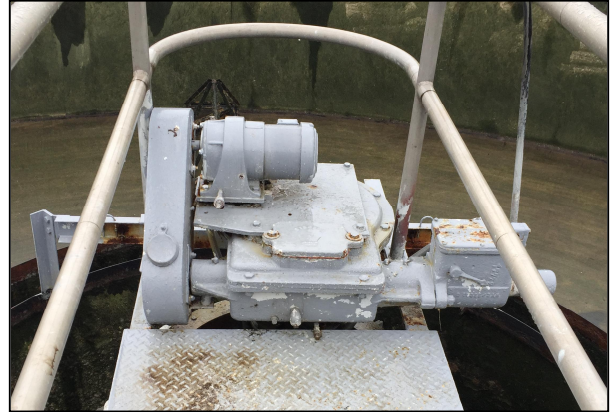
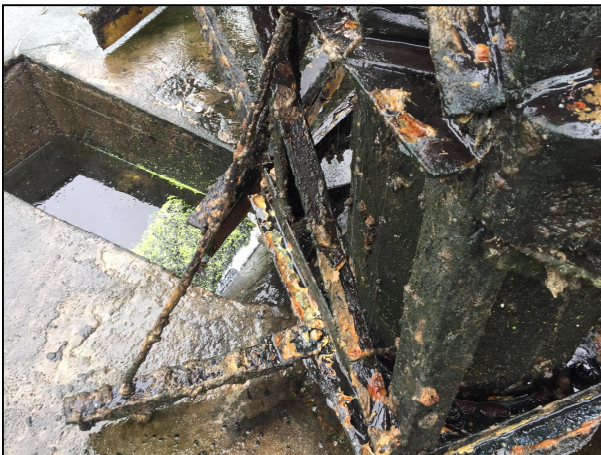
Drive condition – The drive did not show any signs of casting failure or excessive oil leakage. The clarifier

was not run during the inspection however the two operating clarifiers were running smoothly and without excessive noise. Because of the walkway design, access to some areas of the drive requiring routine maintenance are limited and would not be considered safe by today's standards. With the addition of magnetite in the CoMag process it is not clear that the drive would provide sufficient torque for the additional sludge loading. With regular oil changes as recommended by the manufacture and a good maintenance routine, a clarifier drive can be expected to have a life of 25 years. It is not clear how old this drive is but it could easily be more than 25 years. It is recommended that the drive be replaced.

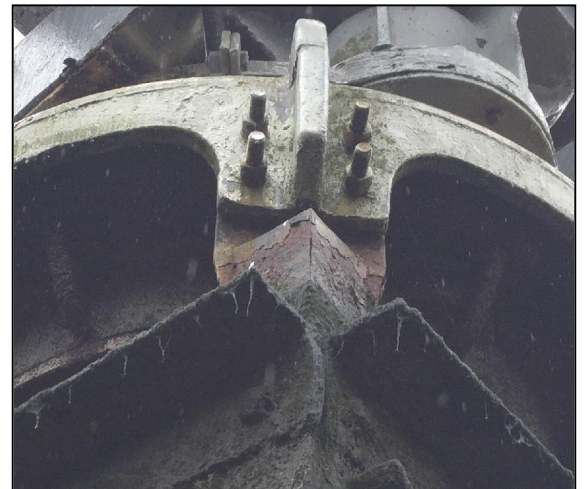
Submerged steel condition – The submerged steel had a lot of corrosive build-up on the surface. When it was scraped away it was evident there was pitting of the steel. The center pier would be a primary concern since only the exterior could be observed. There were areas on the center pier where it appeared the corrosion was more excessive. The connection of the torque cage to the drive showed additional corrosion because of its location

at the air / water interface. This is a critical point since all of the hanging weight and torque are transmitted through this connection.

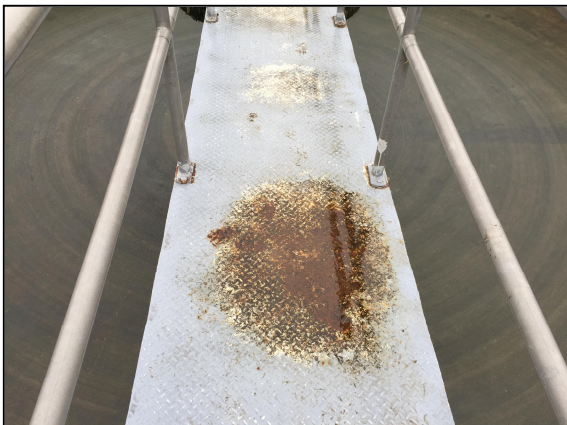
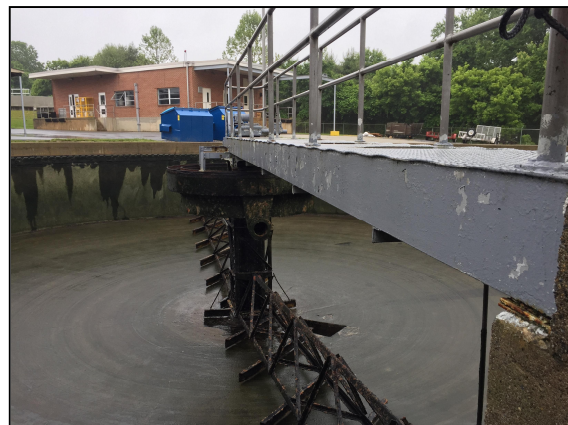
Walkway condition – The walkway has corrosion on the diamond plate surface as well as underneath. The outside edge of the diamond plate is wavy which could be the result of corrosion between the mating surfaces.

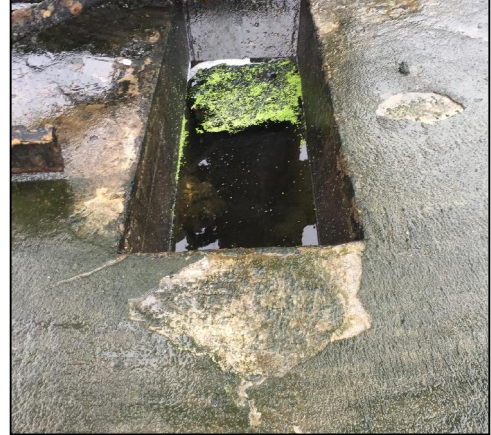
General - The concrete in this clarifier looked to be in fair condition. A small area of the floor grout at the center of the tank was spalled away and it appeared like the grout was very thin, close to .25". At the tank wall the grout appeared to be closer to 1.50" thick. Of the three polishing clarifier tanks, this one was in the best condition. Overall recommendation is to replace the complete clarifier mechanism including submerged steelwork, walkway and drive.

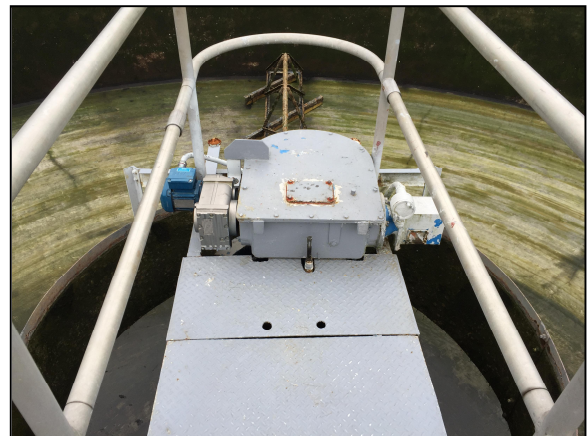
Drive condition – The condition of the drive in this tank was very similar to what is described above in tank 1. As noted above and shown in this photo, the drive is a different design from the other clarifiers.
