> Re: West Goshen Sewer Authority Guaranteed Sewer Revenue Bonds Trust Indenture 2019 Annual Consulting Engineer's Report

WEST GOSHEN SEWER AUTHORITY

2019 ANNUAL CONSULTING ENGINEER'S REPORT WASTEWATER SYSTEM

March 2020

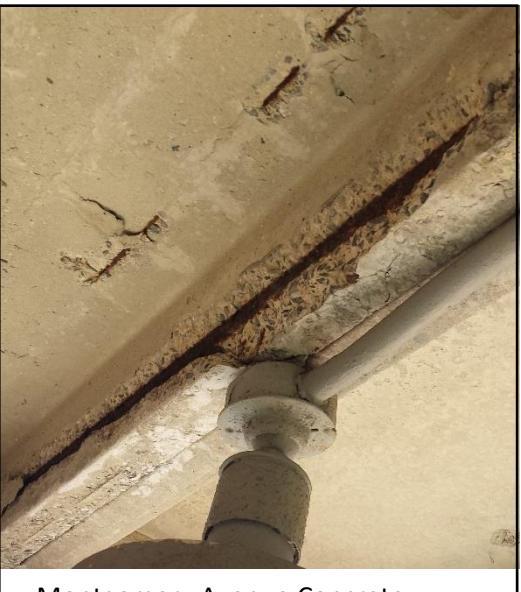
- Concrete cracking, deterioration and exposed rebar in the precast concrete roof planks was observed.

Montgomery Avenue Concrete Deterioration

- Proposed improvement Repair/replace damaged precast concrete roof planks.
- The screening room rollup door jamb is rotting out at its base.
 - Proposed improvement Repair existing door jamb.
- Repointing of the brick mortar joints around the exterior of the building is needed.
 - Proposed improvement Repoint existing brick mortar joints.
- The existing windows and doors in the pump room structure are original. This building is heated in the winter and upgrading of these facilities to new energy efficient units would be beneficial.
 - Proposed improvement Replace existing door and windows.
- HRG observed infiltration on the intermediate level of the dry well at the force main discharge location and near the HVAC ductwork.
 - Proposed improvement Seal leaking wall penetrations.

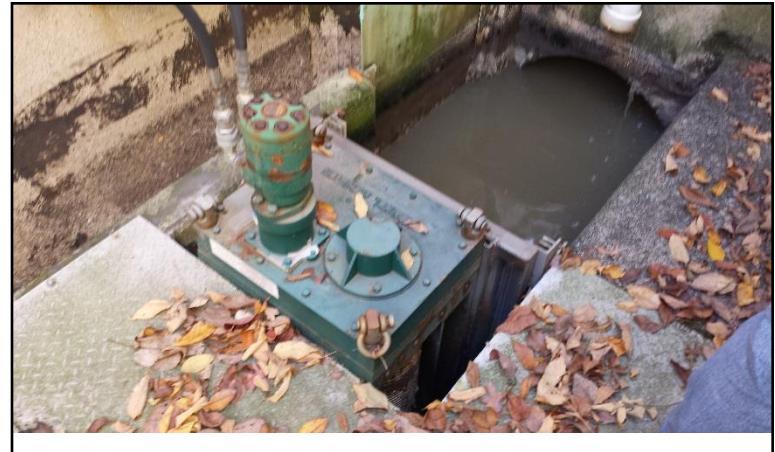
- The wet well contains raw waste which results in a NEC Class I Div. I hazardous area electrical classification. The electrical lighting in the wet well is not rated for use in hazardous areas. In addition, significant corrosion of the electrical components in the wet well was observed.
 - Proposed improvement – Upgrade electrical equipment in the wet well to meet hazardous area requirements.
- Concrete and ferrous metal deterioration from exposure to hydrogen sulfide gas was observed in the wet well. Further investigation is needed to determine the extent of the concrete deterioration throughout the wet well.

Washington Street Equipment

- Proposed improvement Complete investigation to determine full extent of concrete and ferrous metal deterioration. Repair deteriorated concrete and possibly add liner to prevent future deterioration. Repair and replace ferrous metal as necessary and coat/paint to prevent future deterioration.
- HRG observed staining on the front of the building that appeared to come from a roof leak. Township Staff noted that the flat roof was replaced in the past few years. Further investigation should be conducted to determine if the staining is from an active leak and appropriate repairs made based upon the results.
- All HVAC equipment in the building is original and Township staff reports that various units no longer function.

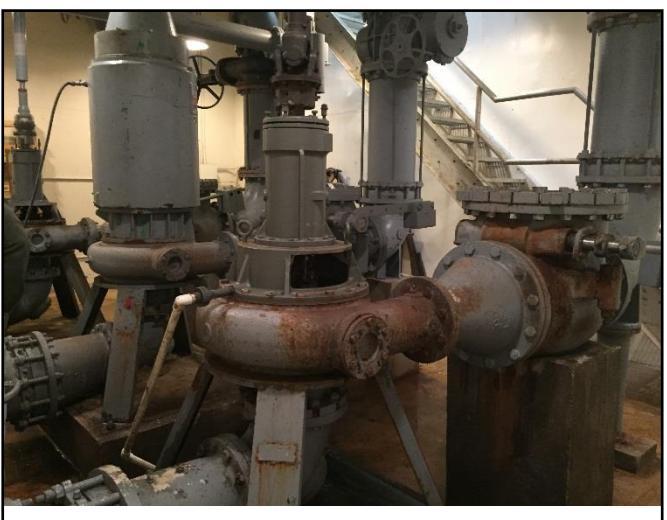
The current means and method of pump and motor removal at the pump station is very difficult as the floor openings are not located above the pumps. This requires Township Staff to have to maneuver the pumps and motors horizontally in order to lift the pumps out. Township Staff reported that an employee was injured during this work in the past. The installation of a pump removal system similar to that installed at Taylor Run Pump Station should be considered. For purposes of this Plan we have not included an estimated cost of this system. A study must be

Westtown Way Equipment

performed to determine the structural requirements needed for the pump removal system and what if any improvements must be made to the building to support it.

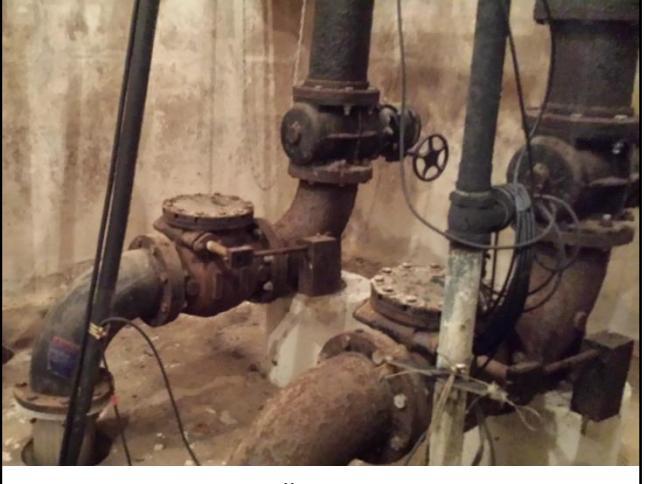
- Proposed improvement Upgrade electrical equipment in the wet well to meet hazardous area requirements.
- The wet well is not physically separated from the electrical room. Additional work should be done to physically separate the electrical gear and provide a safe environment. For example, the wire rope hoist is not explosion proof.
- Concrete and ferrous metal deterioration from exposure to hydrogen sulfide gas was observed in the wet well. HRG observed and Township Staff reported that the header piping and valves in the wet well are experiencing severe corrosion. Township staff noted that

Fern Hill Equipment

they have epoxy painted this pipe and valves the past, but the painting has not held up. Further investigation is needed to determine the extent of the concrete and pipe deterioration throughout the wet well.
