> Re: West Goshen Sewer Authority Guaranteed Sewer Revenue Bonds Trust Indenture 2019 Annual Consulting Engineer's Report

WEST GOSHEN SEWER AUTHORITY

2019 ANNUAL CONSULTING ENGINEER'S REPORT WASTEWATER SYSTEM

March 2020

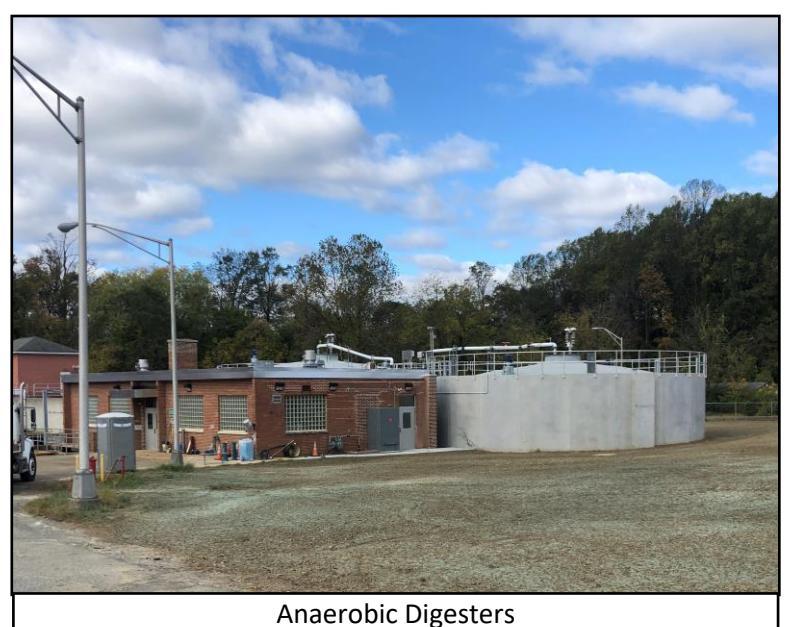
The anaerobic digestion process was completely overhauled as part of the Anaerobic Digester Replacement Project (Contract Nos. 17-3, 17-6, and 17-7) due to the age and condition of the existing facilities and several gas leaks that were identified in the existing building in 2017.

While the Operations Building remains, the previous digesters that shared a common wall with the building were demolished and new precast post-tensioned digesters were constructed. The new digesters closely mirror the previous digesters with a fixed steel cover for the Primary and a

floating gas-holder style steel cover the Secondary. Both Digesters were installed with two draft tube mixers provided in each digester to be able to run the Secondary as a Primary if needed for maintenance purposes. Other improvements include physical separation of the building, providing a physically separated space for the new gas conditioning equipment. Improvements to the Operations Building also included a new roof, now doors, new windows, and conversion

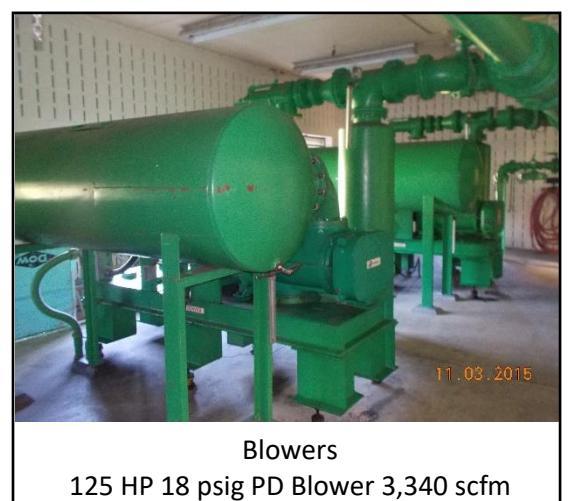
The WWTP utilizes three (3) 125 horsepower 18 psig positive displacement blowers to provide compressed air (capacity of 3,340 scfm each) to the existing aeration tanks through a 16-inch diameter air pipe. The blowers are able to operate at two (2) variable speeds, high and low.

The blowers were installed in 1975 during expansion of the WWTP with repairs and replacement parts provided as needed. Preventative maintenance is completed regularly for the existing blowers including regularly changing oil, cleaning air filters, etc. In 2019, aeration blowers No. 2 and No. 3 were rebuilt.

The 16-inch diameter buried aeration piping from the Blower Building to the Aeration Tanks is actively leaking and is visibly rising from the ground when saturated following a rain event. This pipe should be repaired in 2020 prior to new paving being installed in 2021.

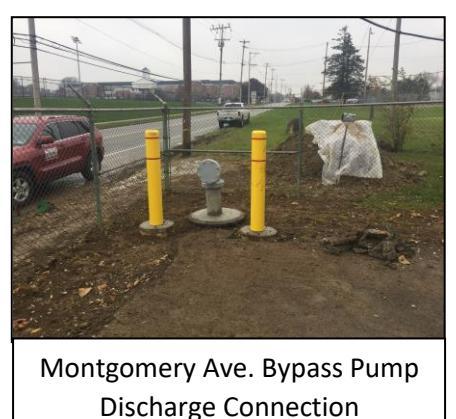
6.1 #1 MONTGOMERY AVENUE

The Montgomery Avenue Pump Station is a dry pit submersible style pump station constructed in the early 1960's. The pump station structure consists of a below grade concrete dry well and wet well, brick masonry building, and precast concrete plank flat roof decking with a rubber roof. A brick masonry screening room containing equipment to screen the influent wastewater into the pump station wet well was later added (construction date unknown). The screening equipment has since been removed and replaced with a hydraulic driven influent sewage grinder. The sewage grinder is designed to reduce the size of the debris to be pumped

in order to minimize the potential for clogging of the pumps, and to convey the debris to the WWTP instead of removing it from the waste stream at the pump station.

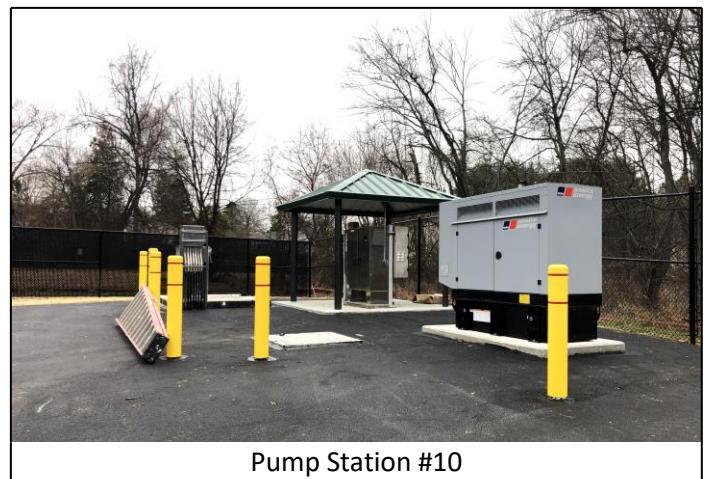
The Woodcrest (Downing Avenue) Pump Station previously consisted of a below ground pumping station constructed in 1976. In 2019, this pump station was replaced with a typical submersible style pump station. The station now consists of a 6' by 8' concrete wet well that contains a sewage grinder and two (identical) dry pit submersible pumps.
