WEST GOSHEN SEWER AUTHORITY

2017 ANNUAL CONSULTING ENGINEER'S REPORT WASTEWATER SYSTEM

March 2018

**2017 ANNUAL CONSULTING ENGINEER'S REPORT
WEST GOSHEN SEWER AUTHORITY
CHESTER COUNTY, PENNSYLVANIA**

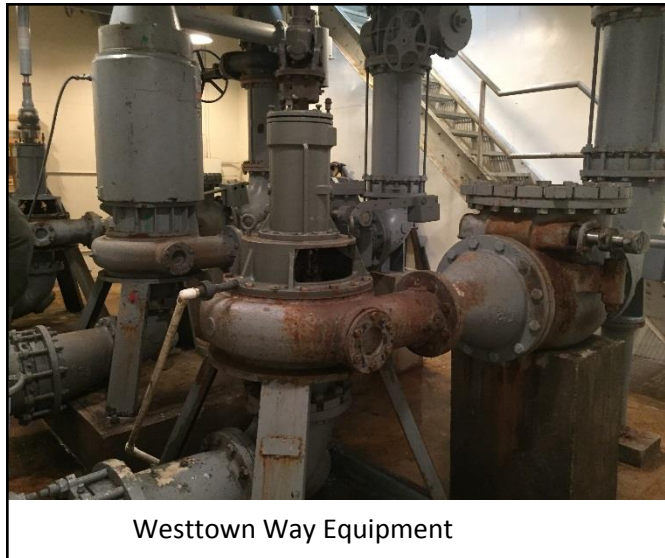
- Township Staff reported and HRG observed grease accumulation in the wet well. Operation staff noted that they currently pump down the wet well and try to pump the grease to the WWTP.

- Proposed improvement – Investigate requiring/enforcing grease removal at establishments to remove grease before it enters the wastewater collection system. Also investigate the installation of a wet well mixing system to keep grease in suspension in the wastewater and prevent from accumulating in the wet well.

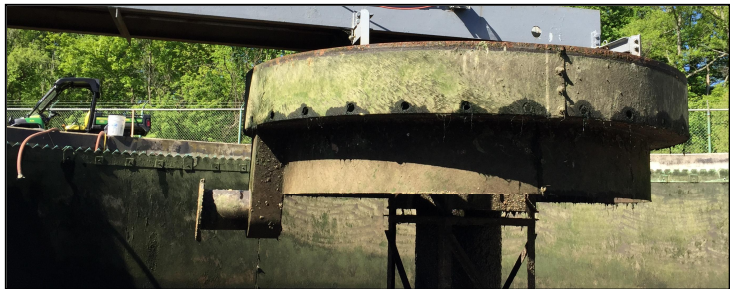
There are three clarifiers 60 foot diameter x 8'-0 SWD. They are Dorr Oliver units with at least the first two units originally installed in the early 1960's. They originally functioned as final stage clarifiers. Over the years another set of final clarifiers was added so these now serve as polishing clarifiers before disinfection.

The original design included a recirculation pipe that took water from a trough around the influent well to a point upstream in the plant. This has since been abandoned.

It should also be noted that these clarifiers do not have a scum skimmer.
