## TMDL STRATEGY FOR CHRISTINA RIVER BASIN WEST GOSHEN TOWNSHIP, CHESTER COUNTY, PENNSYLVANIA

#### 1.0 EXECUTIVE SUMMARY

#### 2.0 INTRODUCTION

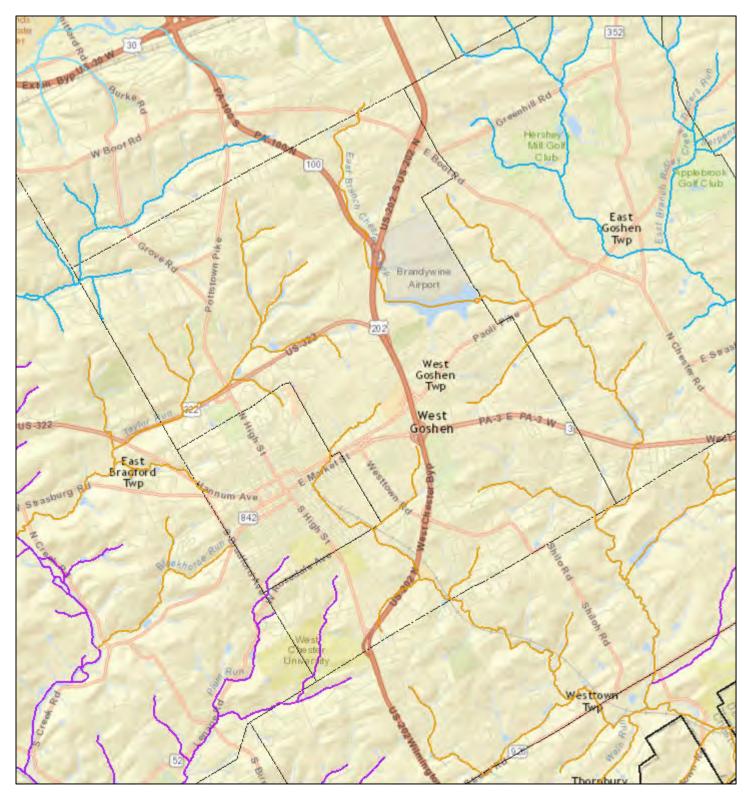
West Goshen Township Stream Designated Use Map

- Cold Water Fish
- Exceptional Value
- High Quality
- Trout Stocking
- Warm Water Fish

\*\*Stream classification maps are located in Appendix A.

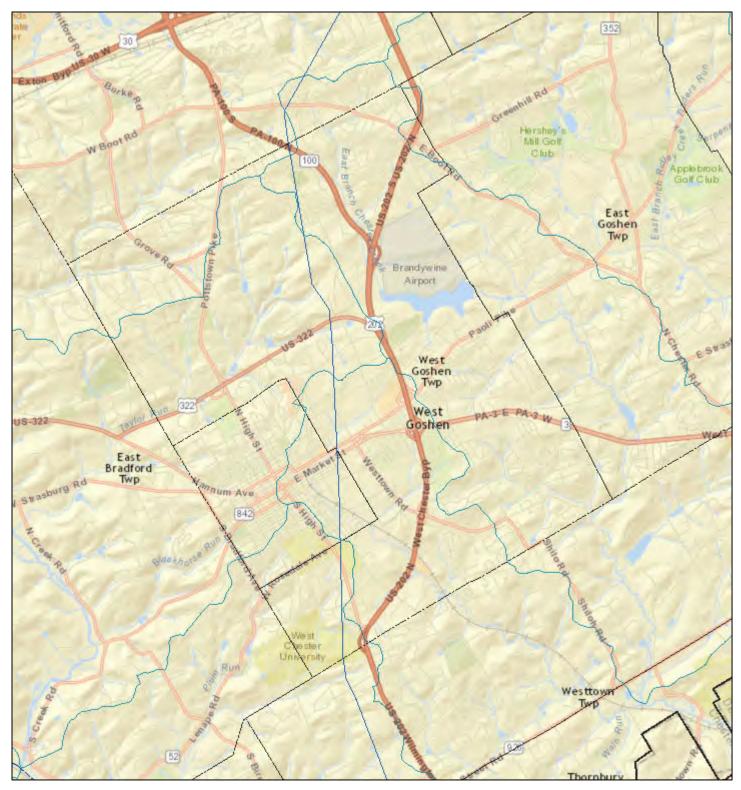
West Goshen Township Hydrologic Unit Code Map

- Hydrologic Unit Code (HUC) 8
- Hydrologic Unit Code (HUC) 12
  - County Boundaries
    - Municipalities
