**MS4 TMDL STRATEGY  
FOR  
DISCHARGES TO IMPAIRED WATERS WITH A TMDL  
GOOSE CREEK WATERSHED**

**PREPARED FOR:  
WEST GOSHEN TOWNSHIP  
PAI 130532**

**WEST GOSHEN TOWNSHIP  
CHESTER COUNTY, PENNSYLVANIA**

**HRG Project No. 004194.0430**

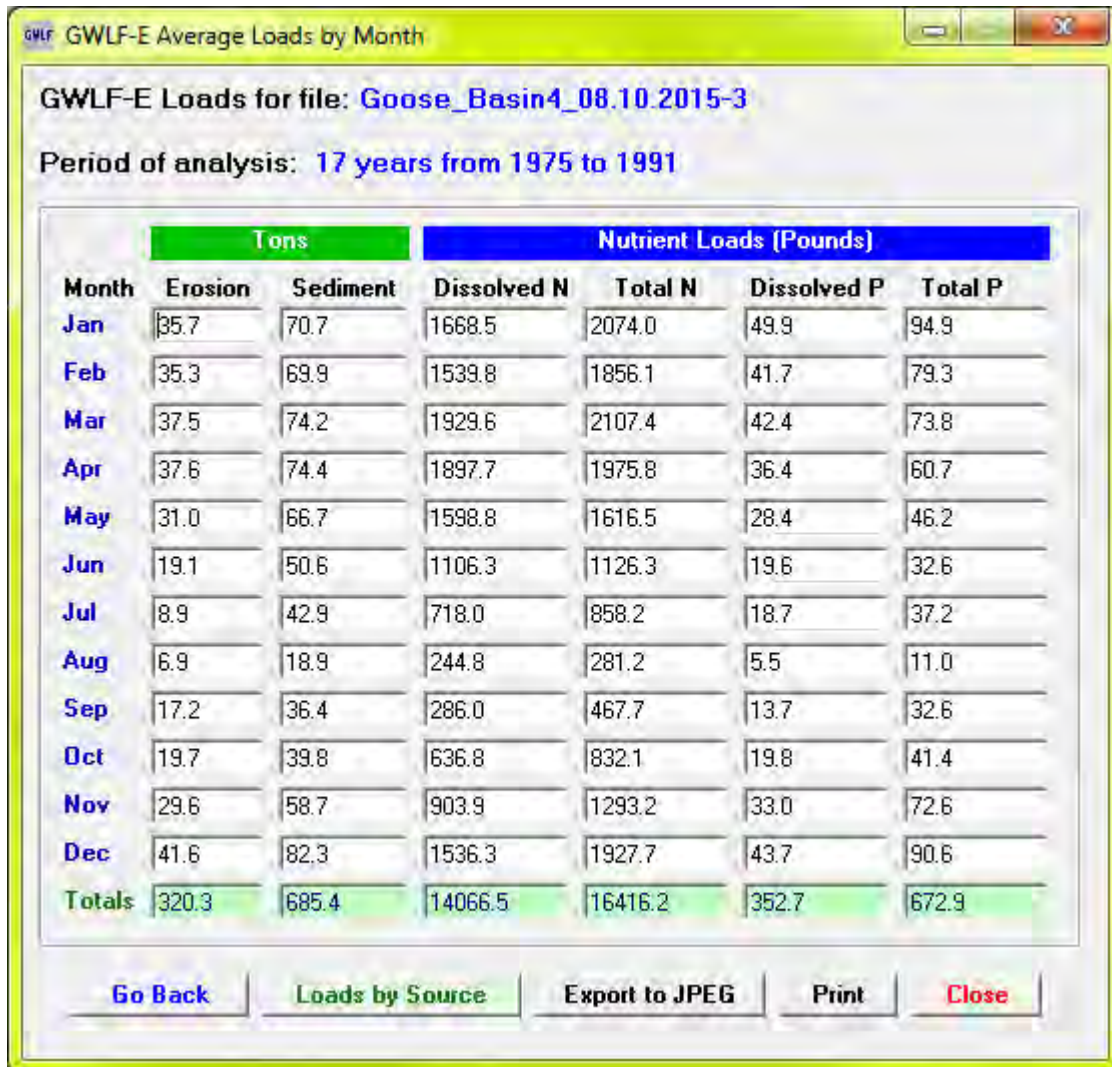
GWLF-E Average Loads by Month

GWLF-E Loads for file: **Goose\_Basin4\_08.10.2015-3**
